Merrimack Estuary and Newburyport Harbor Sediment Management Studies

Honghai Li, Mitchell Brown, Tanya Beck, Ashley Frey,
Julie Rosati, Mark Habel, John Winkelman, Edward O'Donnell,
and Irene Watts

June 2018

Final report

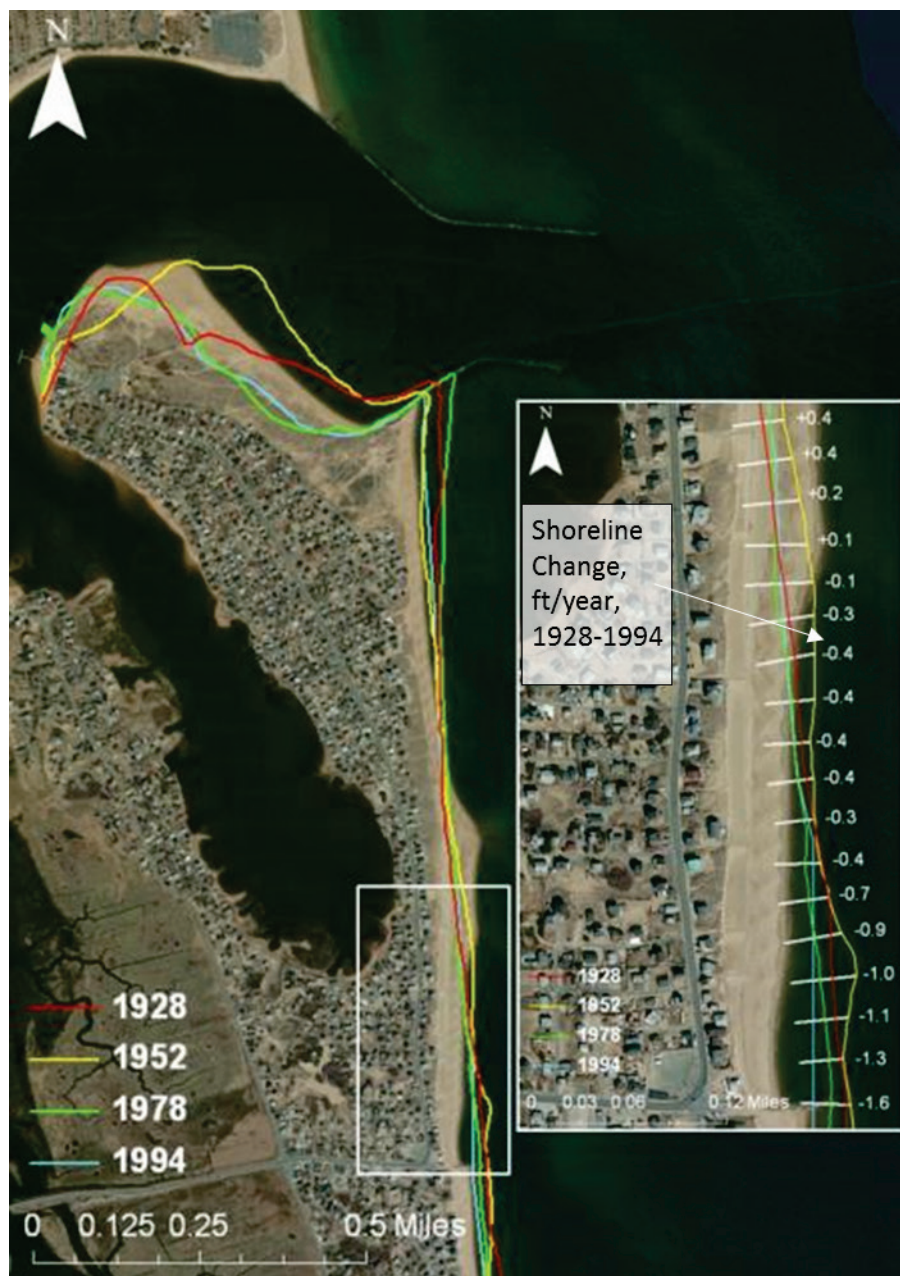
Figure 2. Shoreline position on Plum Island; inset shows shoreline change for selected reach from 1928 to 1994 (from Massachusetts office of Coastal Zone Management [CZM] Historic Shoreline Mapping).

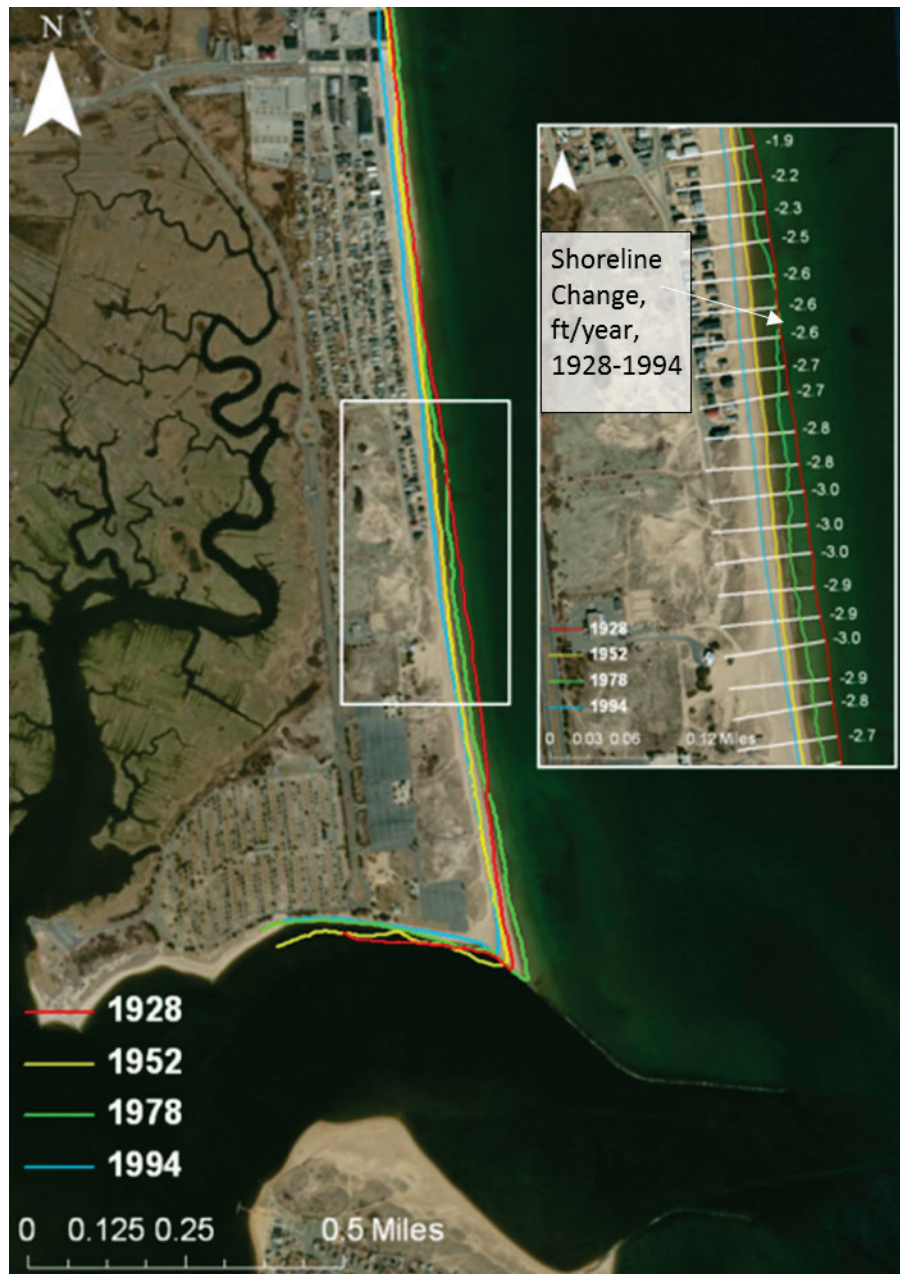
Figure 3. Erosion on Salisbury Beach (From CZM Historic Shoreline Mapping).
